# USCG FY2006 Grant *In-Water Shock Hazard Mitigation Strategies* Final Report October 1, 2008

**Authored by James D. Shafer and Capt. David E. Rifkin (USN, Ret)**

USCG FY2006 Grant  
*In-Water Shock Hazard Mitigation Strategies*

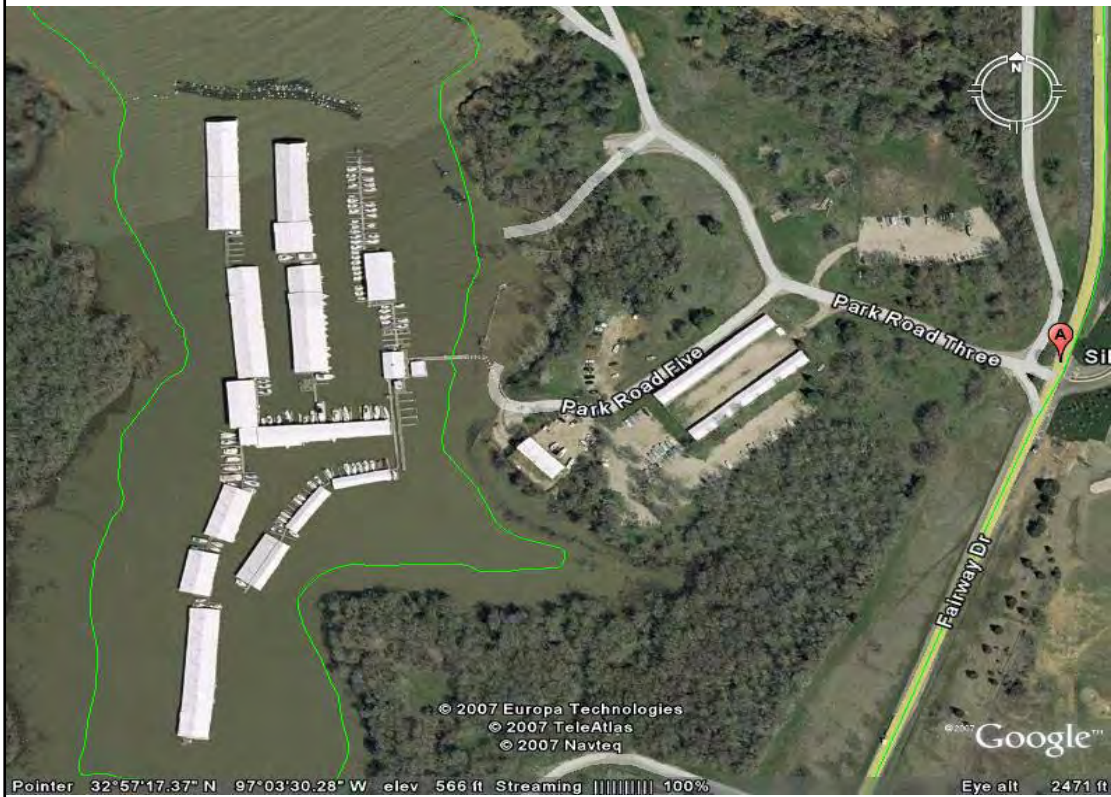
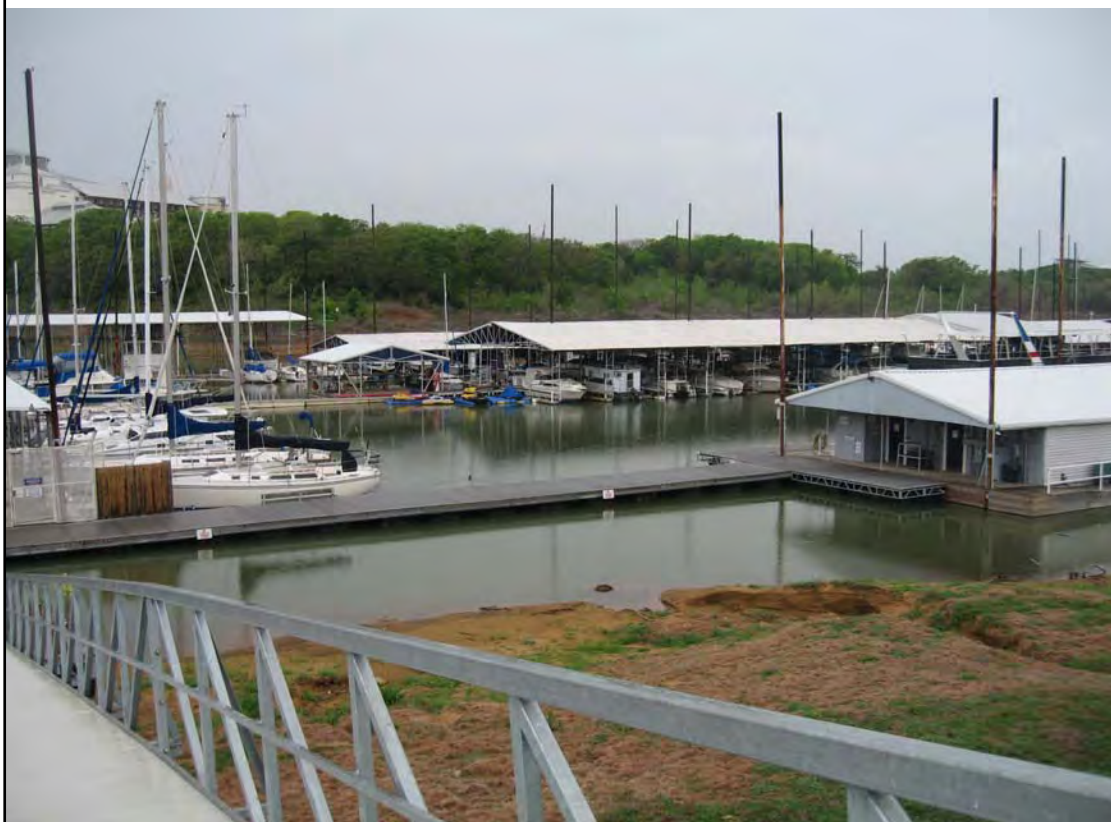
# Sheet 10-1-1, Field Strength/Voltage Data Form

Test number: SLM-FRP-IB-BO, 3-27-07,0800hrs Date: 3/27/2007 Marina/Location Silver Lake Marina, Dallas, TX  
 Vessel Name: No Name Type: Cruiser Hull Material/Coating, if metal: FRP  
 Make/Model: Carver, 1981 Dock #: 100 Slip #: 123 Pedestal #: 123 Water flow at dock: 0 kts  
 Mooring: **Wharf:**  S /  P Side to **Slip:**  Bow In/  Bow Out **Tee Dock:**  S /  P Side to  
 Length/Beam: 28/10' ft **Prop:**  Inboard  Inboard Outboard  Outboard  Sail :  Single  Double  
 Power:  50A/240V  30A/120V  2-30A/120V  50A/240V to 2-30A Other: \_\_\_\_\_

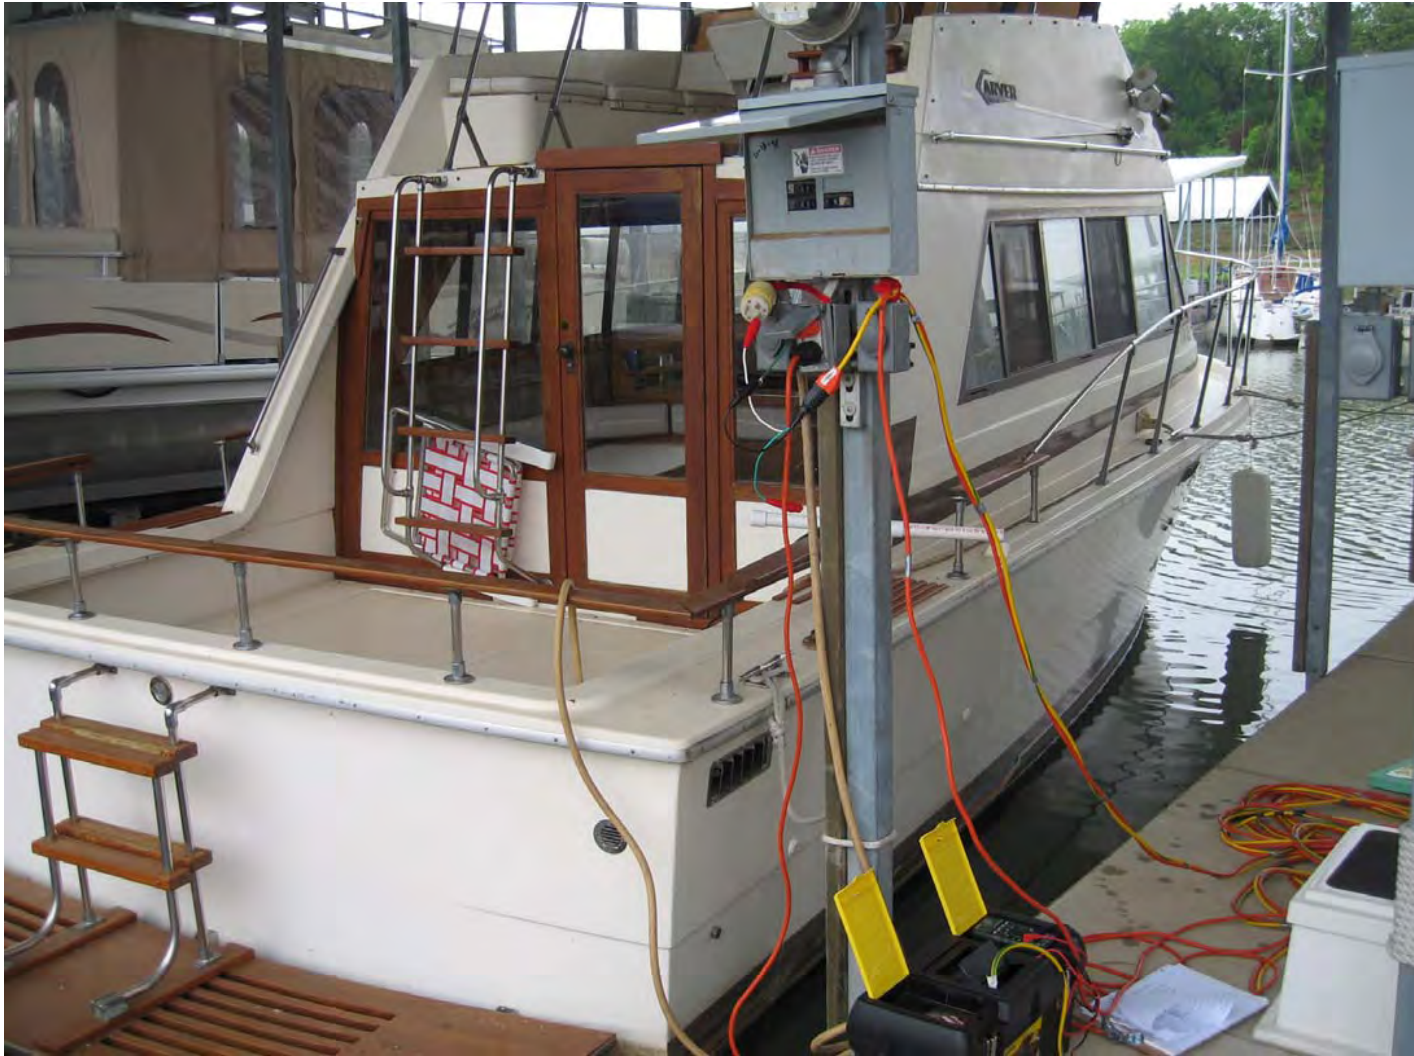
No Name (Sheet 10-1-1,2)

Difference Voltages	1	2	3	4	5	6	7	8
HF1ft(V/ft)	0.029	0.064	0.204	1.447	1.196	1.187	0.299	0.041
HF3ft(V/ft)	0.030	0.059	0.192	0.997	1.246	1.247	0.324	0.042
HF5ft(V/ft)	0.030	0.054	0.160	0.647	0.683	0.634	0.274	0.041
V3ft(V)	0.584	0.891	1.761	6.980	5.360	4.076	1.978	0.600
VF3ft(V/ft)	0.030	0.059	0.155	1.447	1.246	1.247	0.324	0.042

Bonding system:  Intact Pedestal Impedances w/SureTest: H 0.07 N 0.06 G 0.04 ohms  
 Test Current: 3 A Voltage for Test Current 22.7 V Water Type:  Salt  Brackish  Fresh  
 Salinity: 0.298 g/l TDS: 0.422 ppt pH: 7.28 Temp: 63F  
 Conductivity: 0.525 ms/cm@1ft 0.605 ms/cm@3ft 0.459 ms/cm@5ft Water path (Ω): 7.57

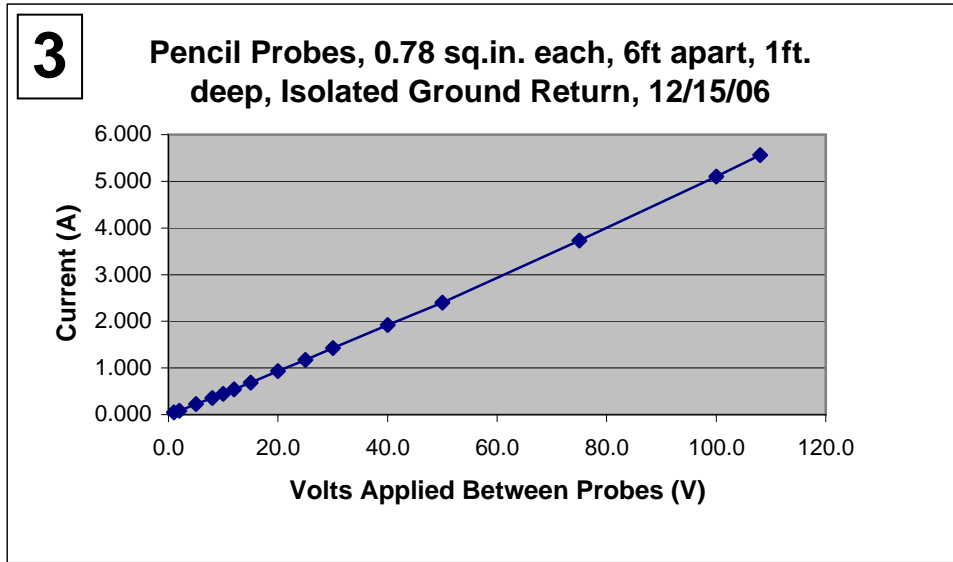
1in. of pencil probes exposed

Volts	Amps
1.0	0.045
2.0	0.085
5.0	0.223
8.0	0.356
10.0	0.448
12.0	0.544
15.0	0.686
20.0	0.934
25.0	1.170
30.0	1.423
40.0	1.920
50.0	2.400
75.0	3.730
100.0	5.100
108.0	5.560

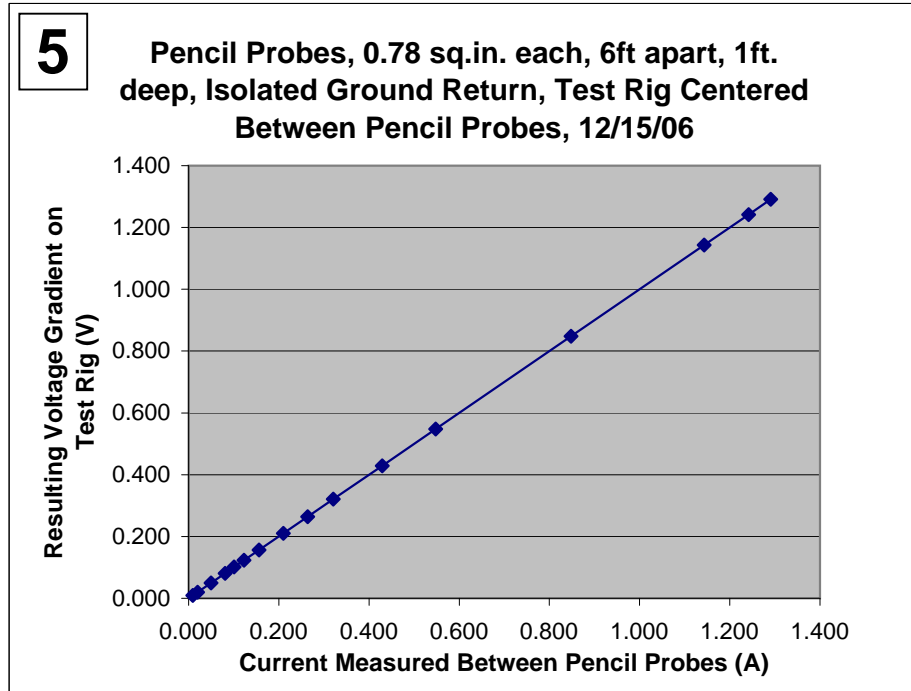
1 in. of pencil probes  
 exposed, 2ft wide field  
 probes between probes.

Volts Applied	Amps	2ft Voltage Gradient Volts
1	0.05	0.009
2	0.10	0.020
5	0.22	0.050
8	0.38	0.081
10	0.47	0.101
12	0.57	0.123
15	0.72	0.156
20	0.97	0.210
25	1.21	0.264
30	1.45	0.321
40	1.96	0.429
50	2.44	0.548
75	3.74	0.848
100	5.09	1.143
108	5.50	1.242
112.5	5.77	1.291

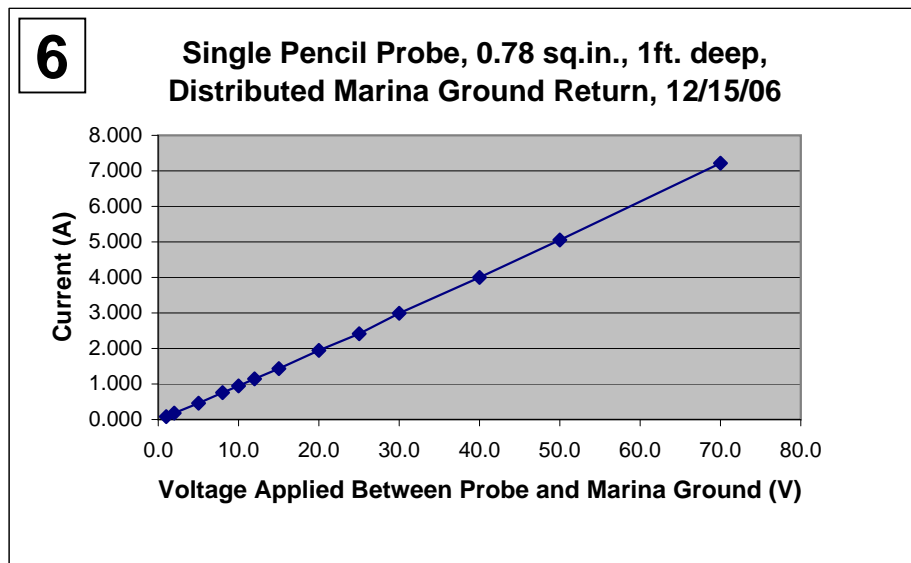
Single pencil probe, 1" exposed, marina ground return

Volts	Amps
1.0	0.084
2.0	0.177
5.0	0.455
8.0	0.755
10.0	0.944
12.0	1.140
15.0	1.430
20.0	1.945
25.0	2.410
30.0	2.990
40.0	4.000
50.0	5.050
70.0	7.220

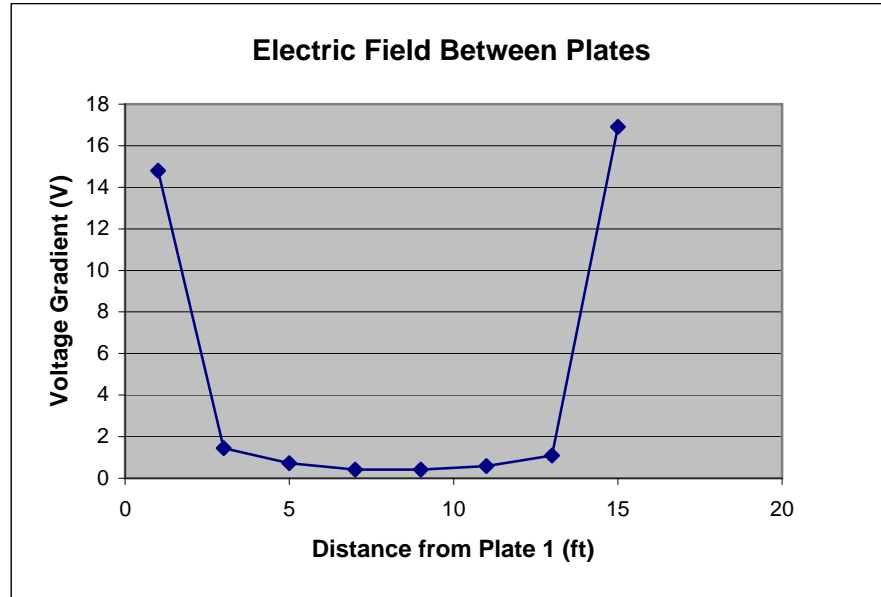
Voltage applied to plates: 40VAC

Distance of test rig center from plate #1 (ft)	2' Voltage Gradient (V)
1	14.8
3	1.45
5	0.73
7	0.42
9	0.41
11	0.59
13	1.100
15	16.90
Sum of voltages =	36.40

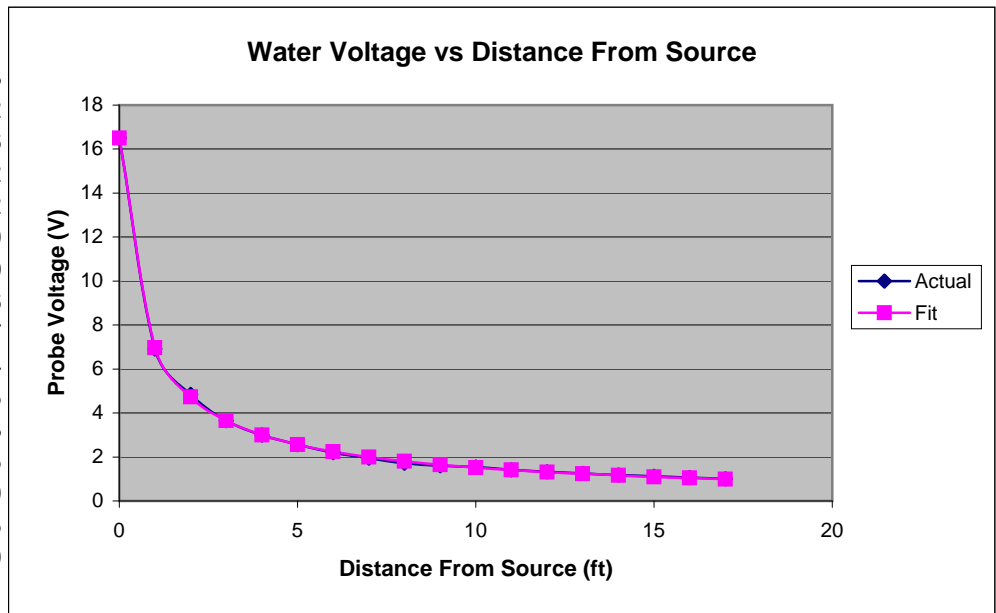
## Sheet 13C, Water Voltage vs Source Distance

Feet from Prop	Water Voltage (V)	Water Voltage Fit from Equation (V)
0	16.5	16.4981
1	6.91	6.9633
2	4.85	4.7362
3	3.65	3.6516
4	3.00	2.9972
5	2.56	2.5552
6	2.20	2.2349
7	1.95	1.9910
8	1.72	1.7986
9	1.60	1.6427
10	1.54	1.5134
11	1.41	1.4045
12	1.32	1.3113
13	1.25	1.2305
14	1.18	1.1599
15	1.12	1.0975
16	1.06	1.0419
17	1.00	0.9921
